Exploration of the Feasibility of
Production Rolling an Optimum
Aluminum Alloy System Which
Has an As-Welded Yield
Strength of 30 KSI Minimum

FINAL REPORT

R.W. Rogers, Jr.
W.D. Vernam
M.B. Shumaker
Aluminum Company of America
Alcoa Laboratories

September 22, 1976

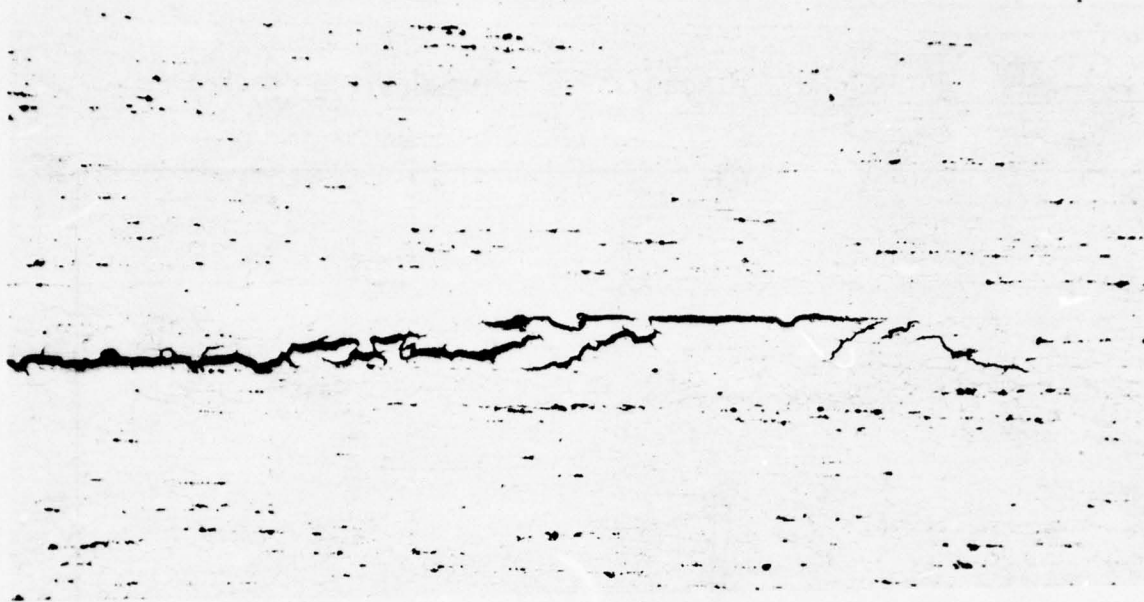
Figure 4

CS19-H3E19 DCB SPECIMEN IN AS-FABRICATED CONDITION

Illustrates cracking (far right) at the crack tip in T/2 plane.

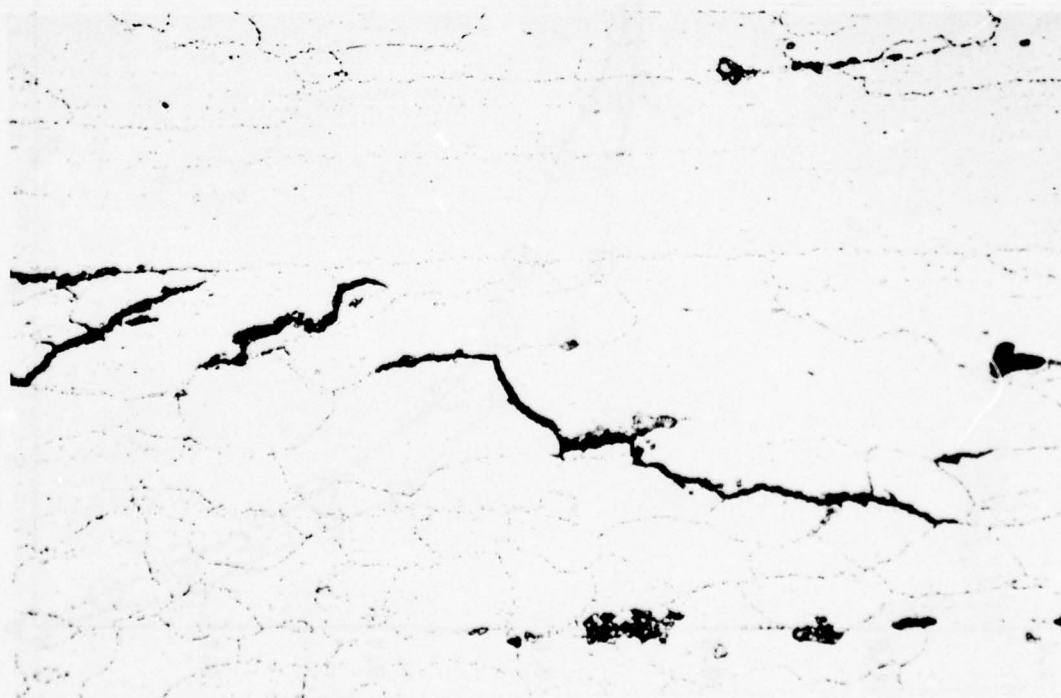
Figure 5

ENLARGEMENT (500X) OF CRACKING AT THE CRACK TIP IN FIG. 4

Note outlining of grain boundaries with precipitate and intergranular path of cracking.
